**Asrama Raya Sdn Bhd**  
**(ARSB)**

**Environmental**  
**Monitoring**  
**Report**  
**2024**

**December 2024**

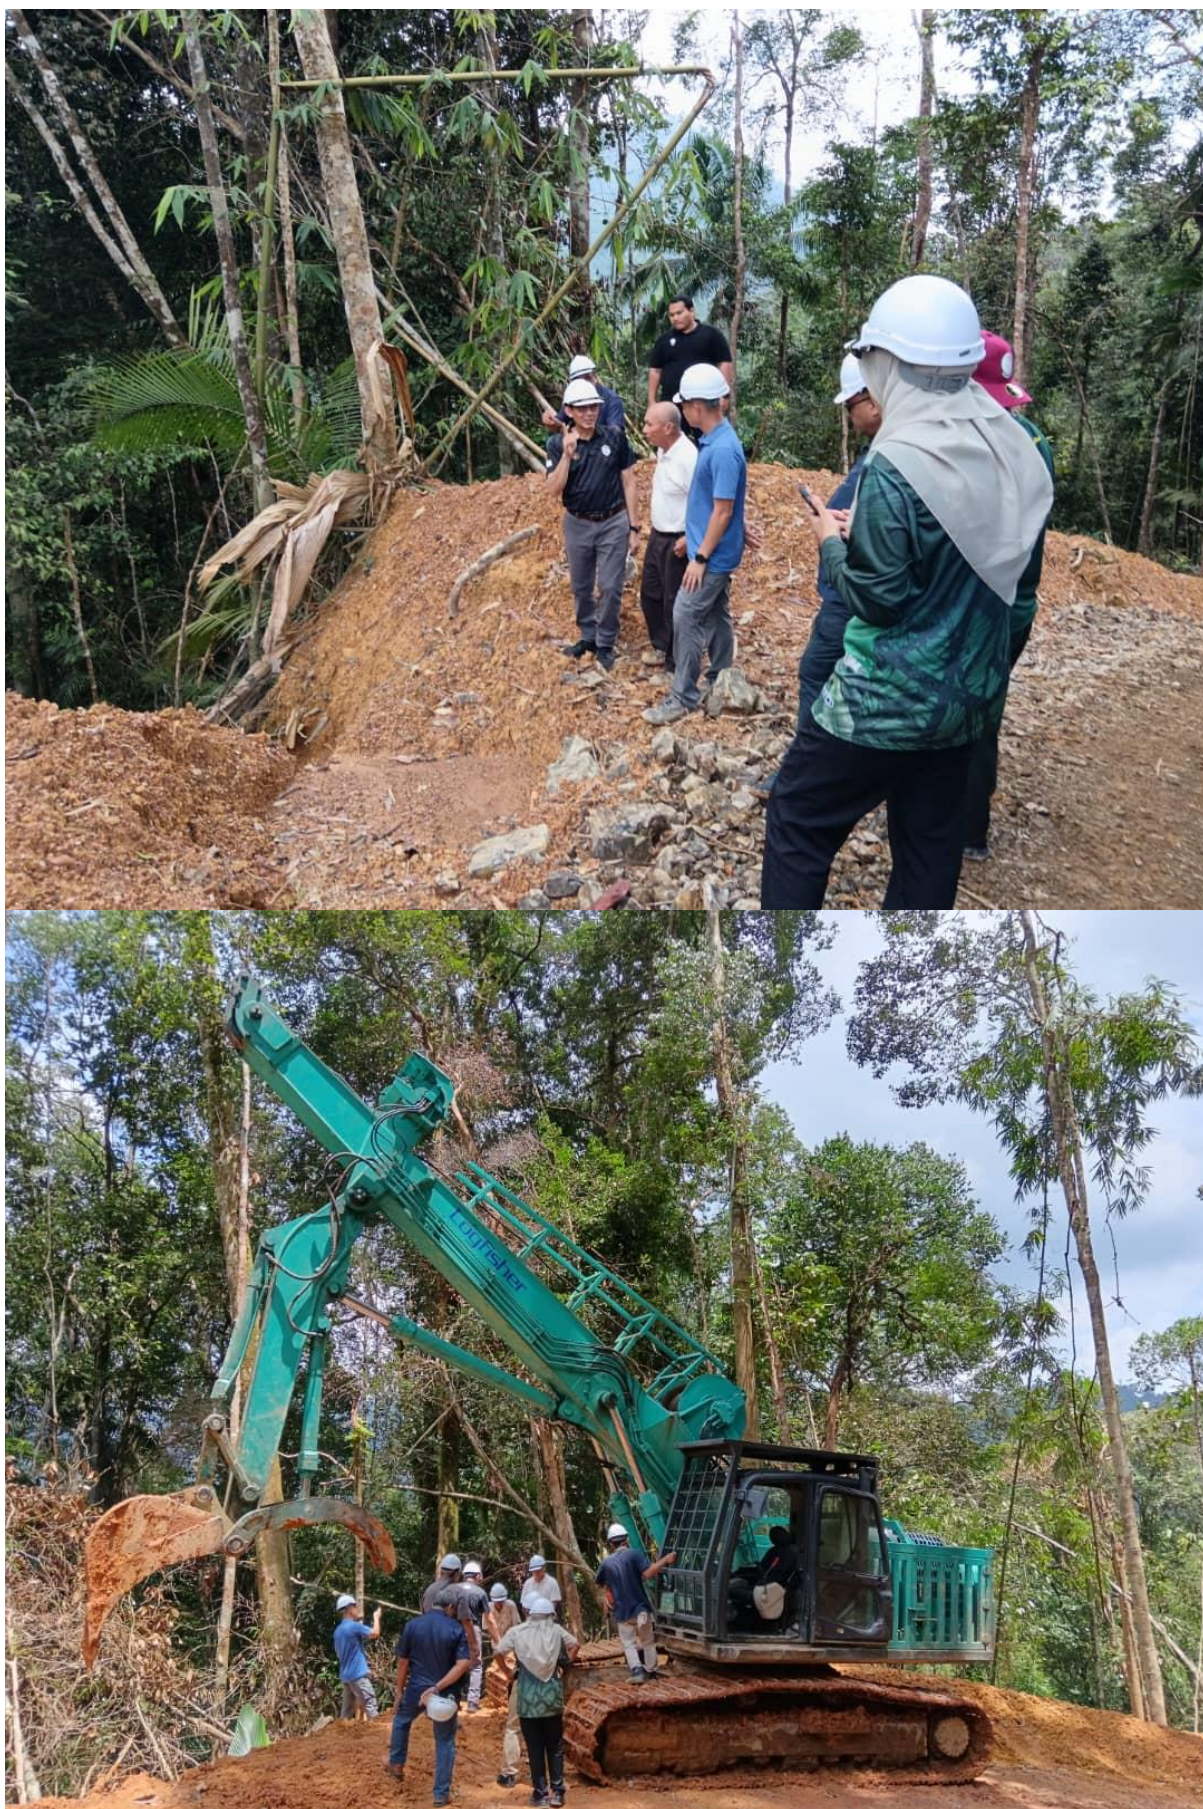
Figure 3. Forest manager is monitoring the forest harvesting activities.

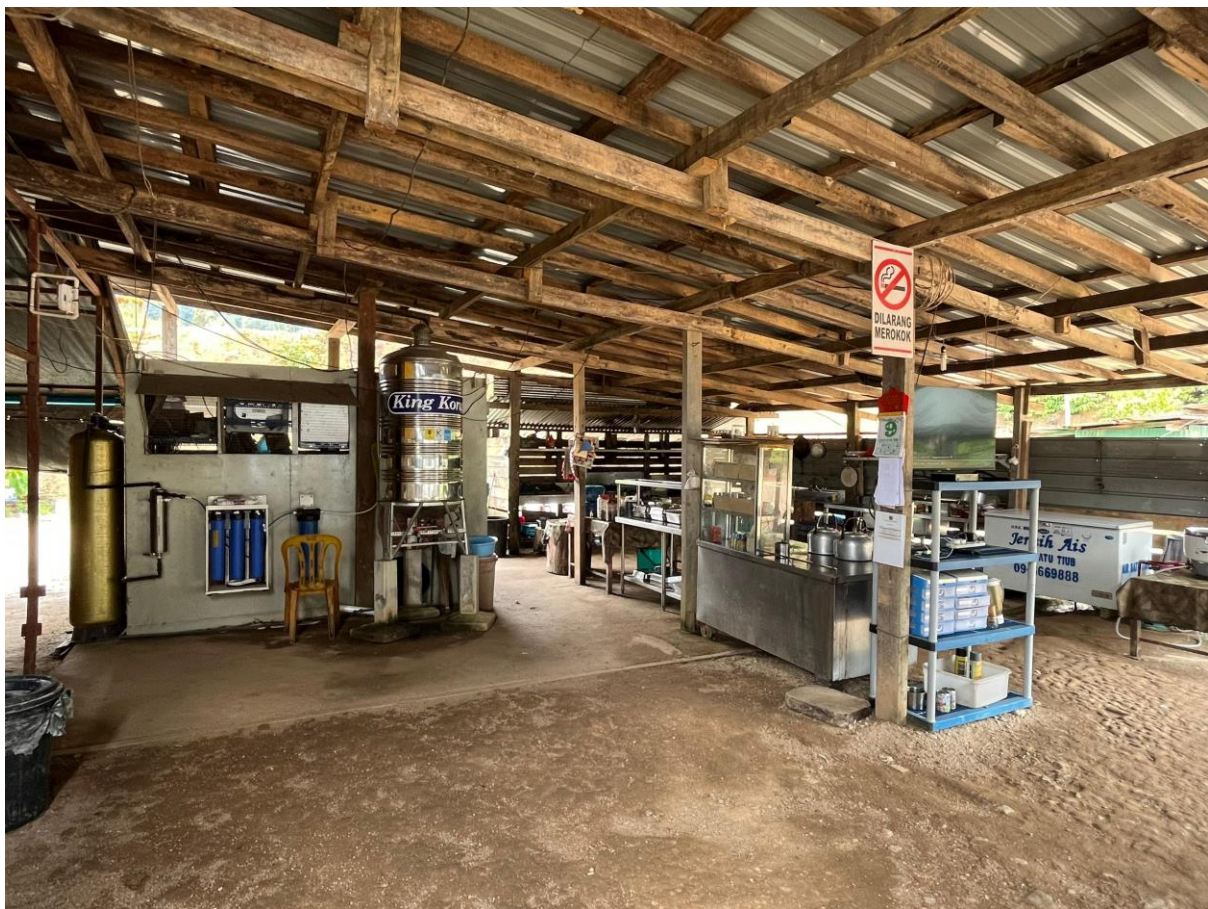
Figure 4. Logging camp of ARSB HS Petuang concession is clean and well maintained.

- The logging base camp and logging workshop were clean and well maintained (Figure 4 and 5).
- All the hazardous substances for forest harvesting operations were handled, stored and disposed based on the standard of procedure (SOP).
- The conditions and usage of fuel tank and lubricant oil were recorded and under controlled condition.
- All the wastes and scheduled wastes were taken out from ARSB HS Petuang concession / forest for disposing.

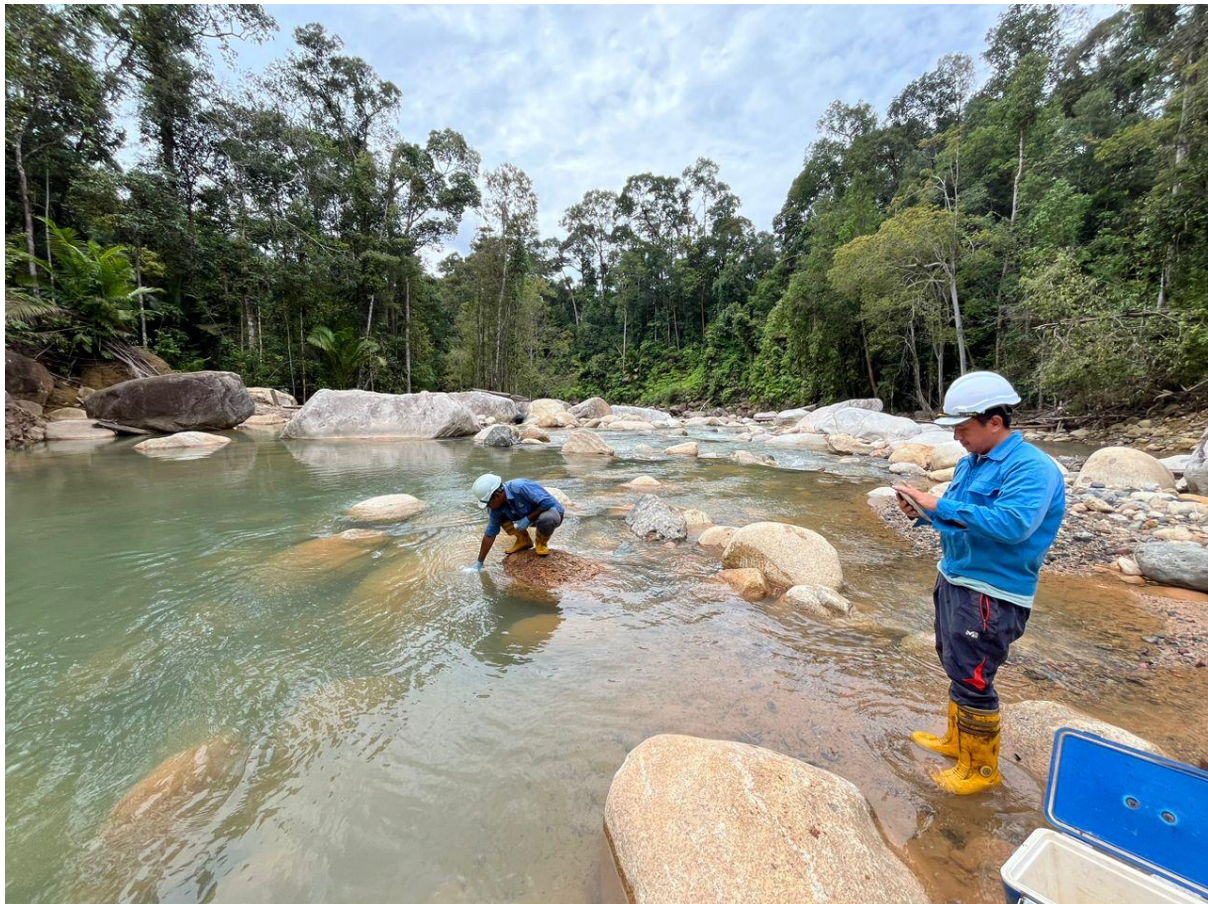
Figure 6. River at compartment 62 block B, ARSB HS Petuang concession shows greenish colours.

- Most of the rivers in ARSB HS Petuang concession are clean and river shows greenish colours (Figure 6).

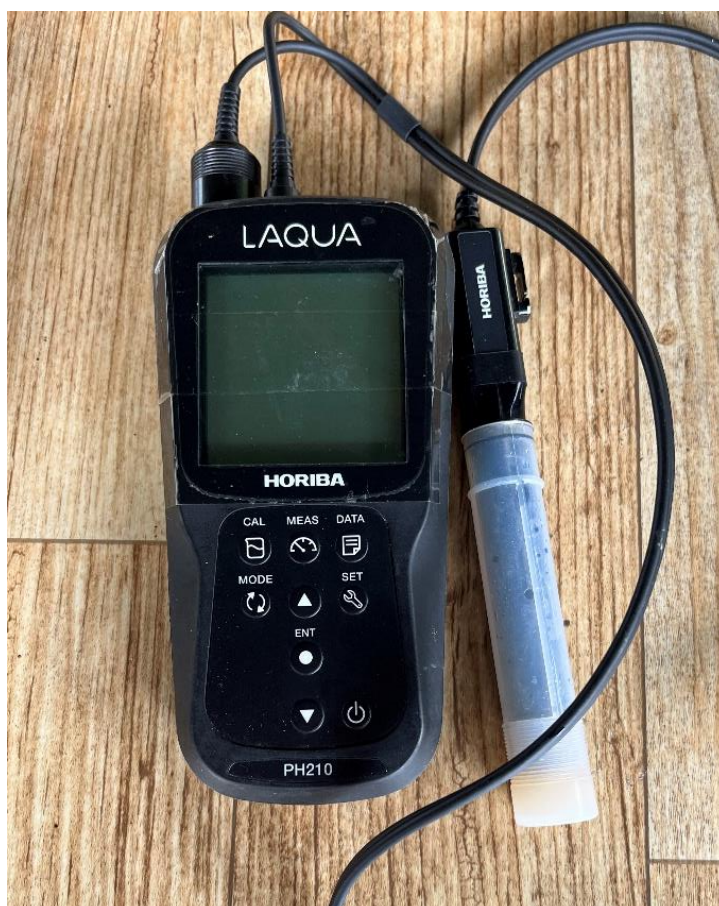
Figure 7. Horiba LAQUA pH210 pH/ temperature meter was used for measuring pH and temperature directly at site.

In situ measurement was conducted for temperature, pH and dissolved oxygen (DO) and turbidity. Temperature and pH were measured using Horiba LAQUA pH210 pH/ temperature meter, dissolved oxygen (DO) was measured using YSI 550A dissolved oxygen instrument and turbidity was measured using Eutech Tn100 turbidity meter. Water for total suspended solid (TSS), chemical oxygen demand (COD) and ammoniacal-nitrogen (NH<sub>3</sub>-N) analysis was collected using plastic bottle. All samples were preserved using ice (<4 °C) before being taken to the laboratory for analysis.

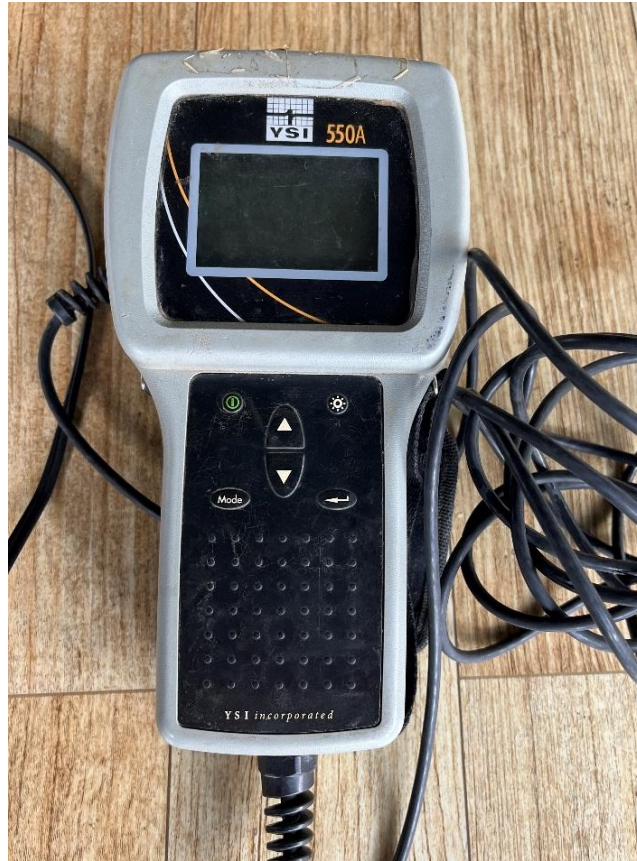
Figure 8. YSI 550A dissolved oxygen instrument was used for measuring dissolved oxygen directly at site.

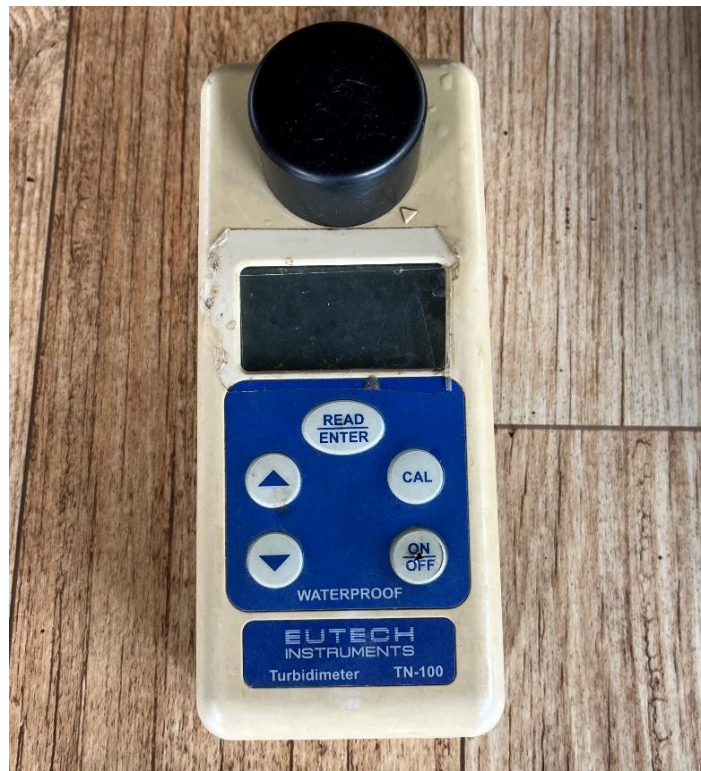
Figure 9. Eutech Tn100 turbidity meter was used for measuring turbidity at site.

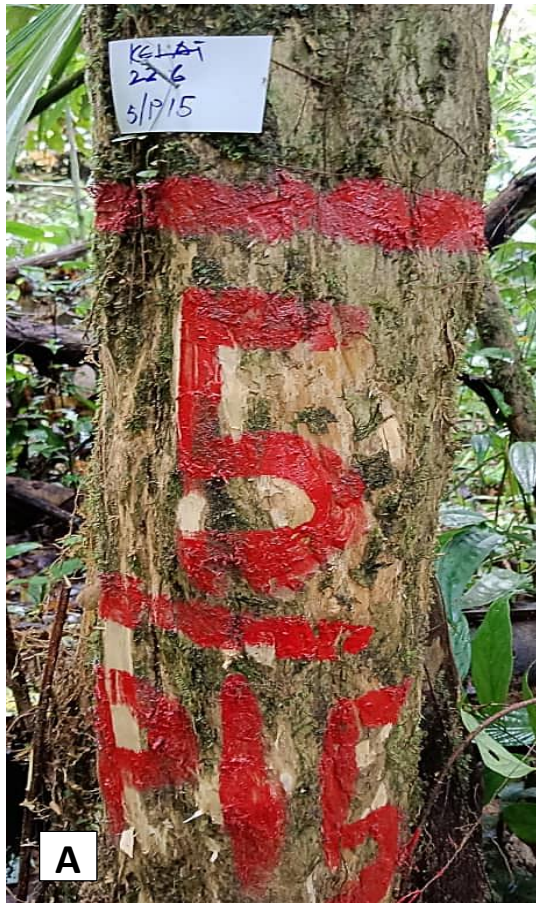
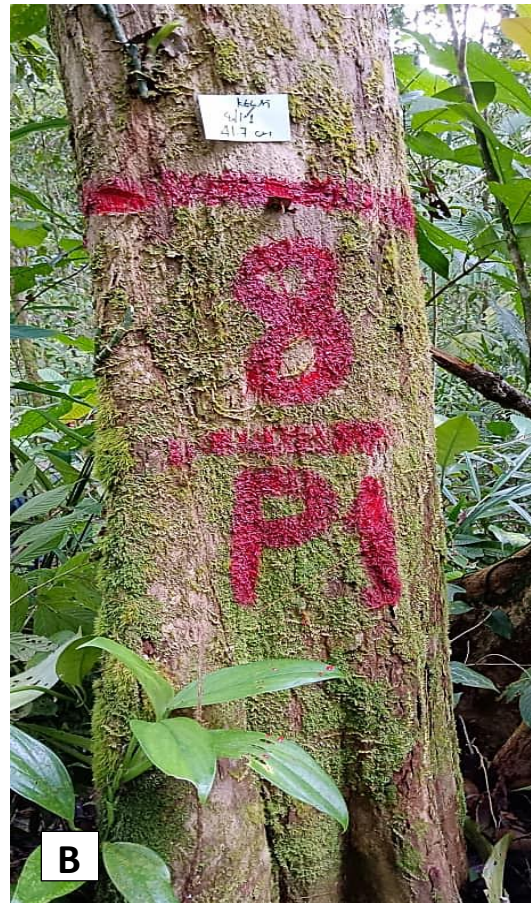
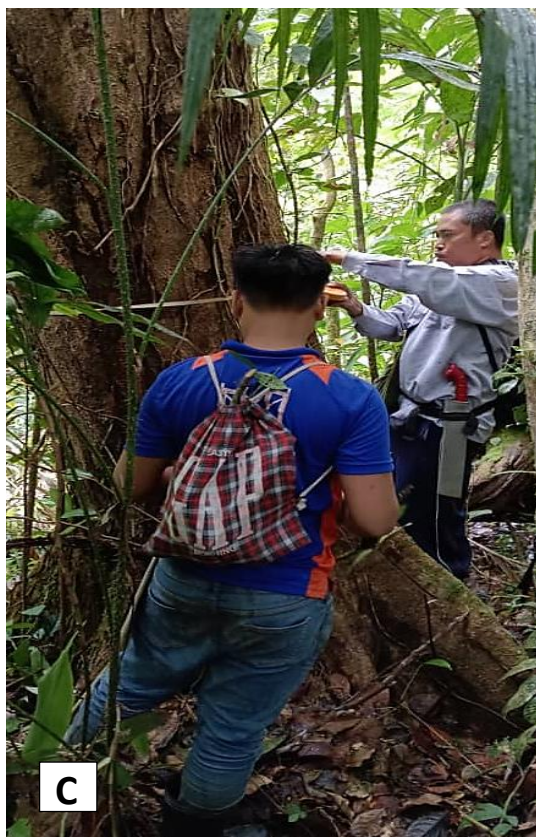
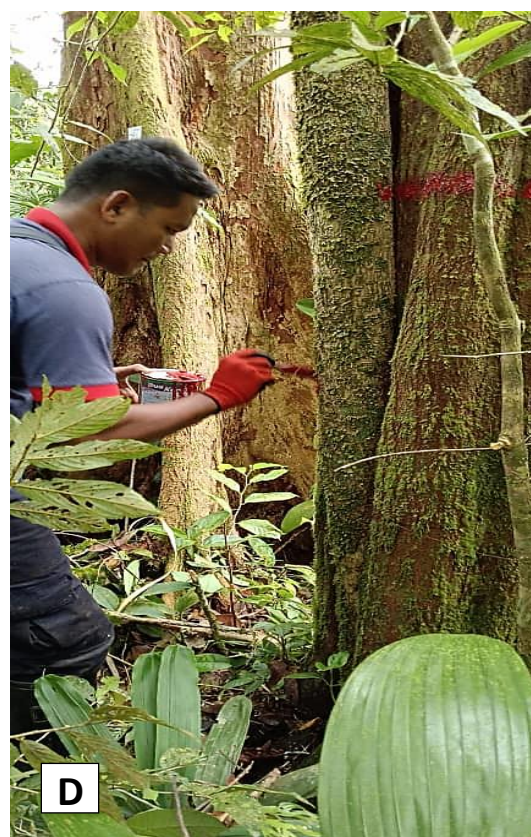
- The tree DBH and stand volume were recorded and calculated.
- The PSP were monitored annually and the measurement of tree growth will be conducted after 3 years.
- **Refer permanent sample plot (PSP) data for PSP monitoring records.**

Figure 10. PSP setup and tree inventory

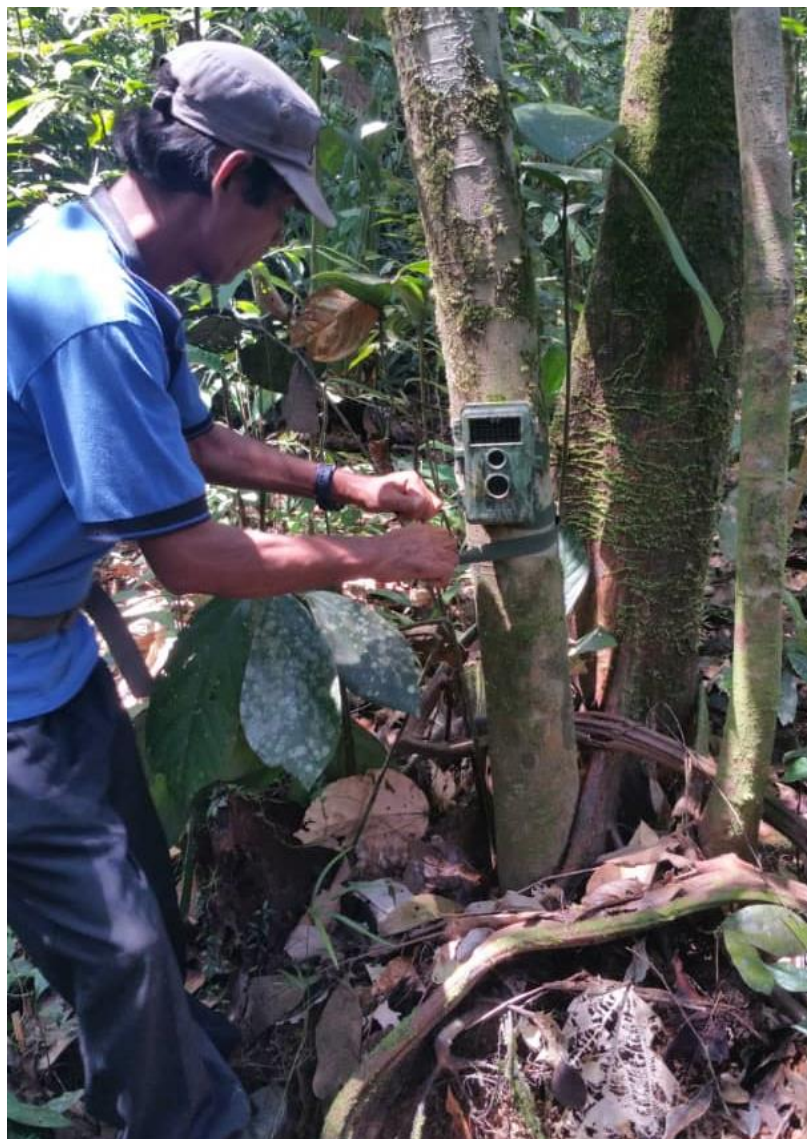
Figure 13. Forest supervisor/ 'Kepala Hutan' set up the camera trap by mounting up the camera at the tree.
